Manhole Inspection Summary

Manhole # S05UU1006MH

Insp Date: **9/26/06 8:32 AM**

Location Address: **3500 W NORTHERN PKWY**

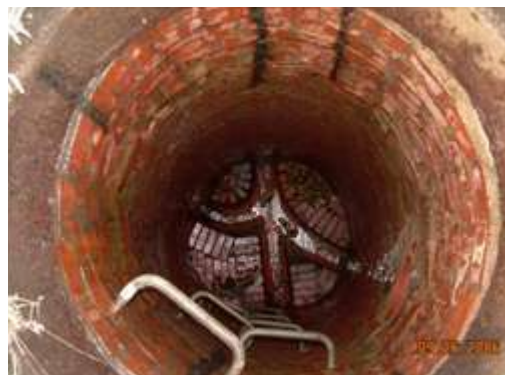
Top View

Frame leaks. Adjustment, Corbel and Barrel infiltration. Bench debris.

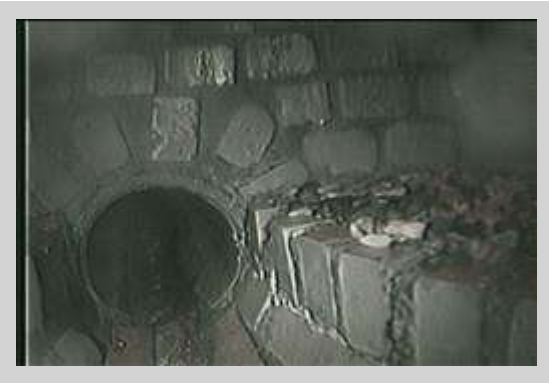
8 in. Circular Gravity Sewer Pipe Out @ 12 O'Clock

Bench deterioration.

Infiltration: **None** Pipe Seal Cond: **Cracked**

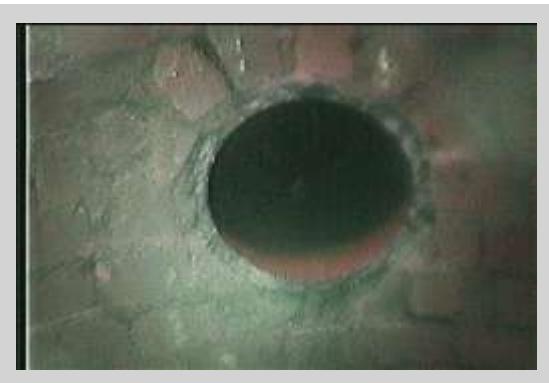
8 in. Circular Gravity Sewer Pipe In @ 4 O'Clock

Corbel deterioration and infiltration.

Deposits: ☐ None ☐ Mud ☐ Sludge ☐ Debris ☒ Grease

Infiltration: **Evidence** Pipe Seal Cond: **Unknown**

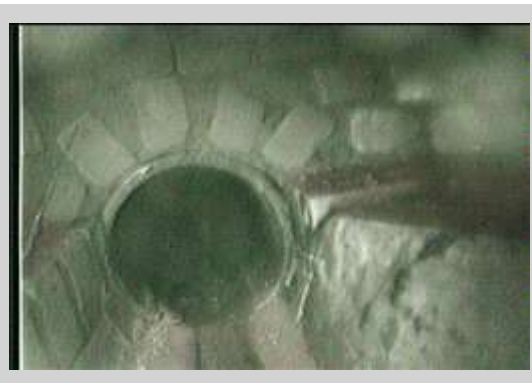
Drop In @ 4 O'Clock

Drop: **Outside** Rod and Bar
Angled: **Yes** Reading: **13.36** (ft.)
Inv Depth: **14.36** (ft.)

Drop Condition: **Open**

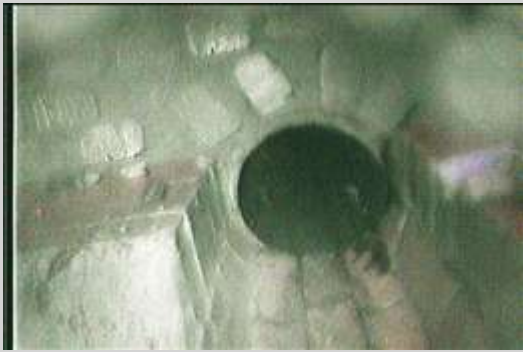
Pipe In @ 6 O'Clock

Infiltration: **Evidence** Pipe Seal Cond: **Unknown**

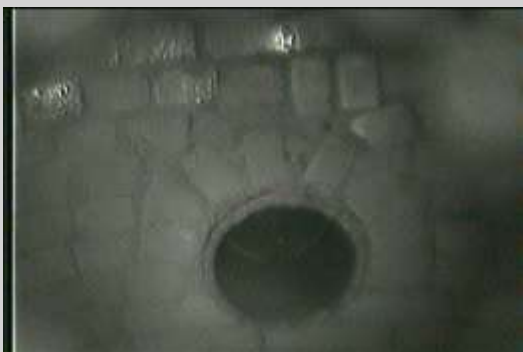
Pipe In @ 10 O'Clock

Infiltration: **Evidence** Pipe Seal Cond: **Unknown**

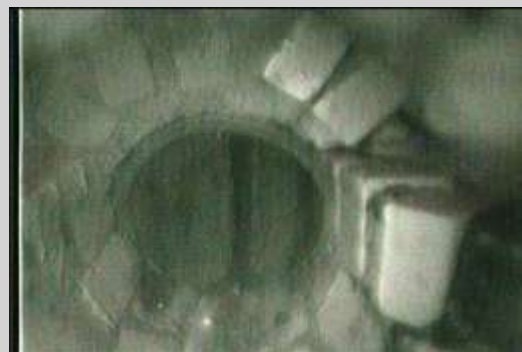
Drop In @ 10 O'Clock

Drop: **Outside** Rod and Bar

Drop Condition: **Open**
